Avon-Heathcote Ihutai Estuary Edge Condition Inventory

Christchurch City Council

IZ128500-A.CS.EV.1-NM-RPT-0001 IZ128500-NM-RPT-0001| B

12 August 2019

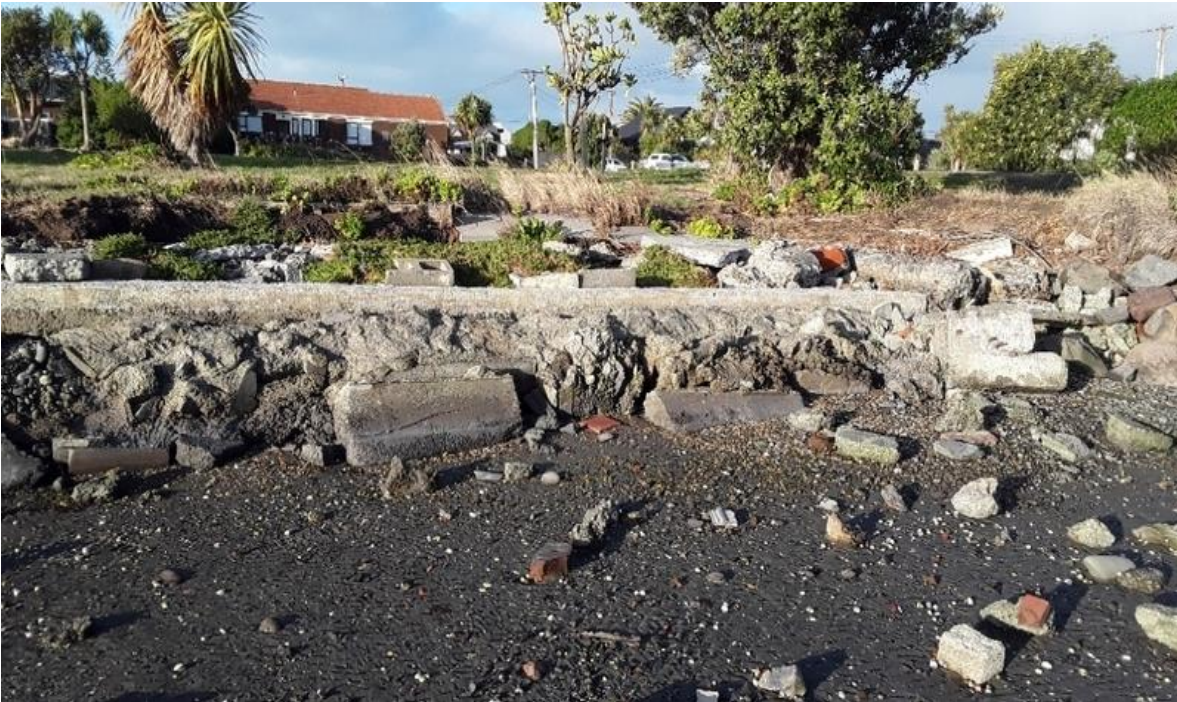
Figure 5: Structure IS10 - low lying concrete wall, condition graded 'D' rather than 'E' due to still providing some functionality against erosion (Jacobs, 2019)

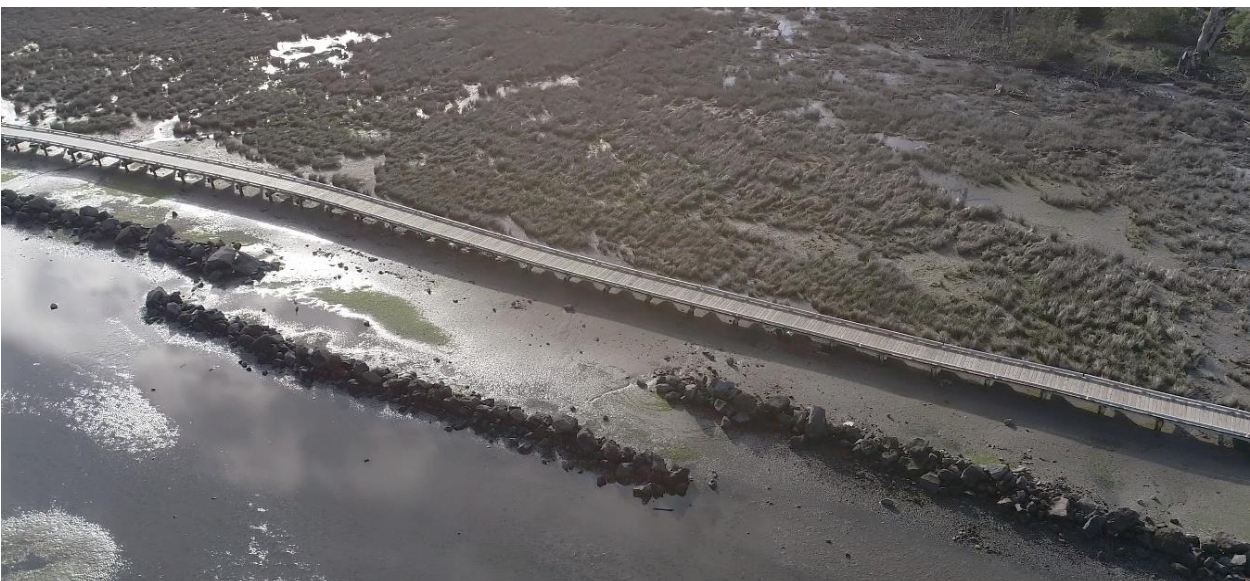
Figure 6: IS45-IS43 low lying revetment graded B* which have been put in place to break up wave energy to protect the boardwalk and saltmarsh (ECan, 2019).

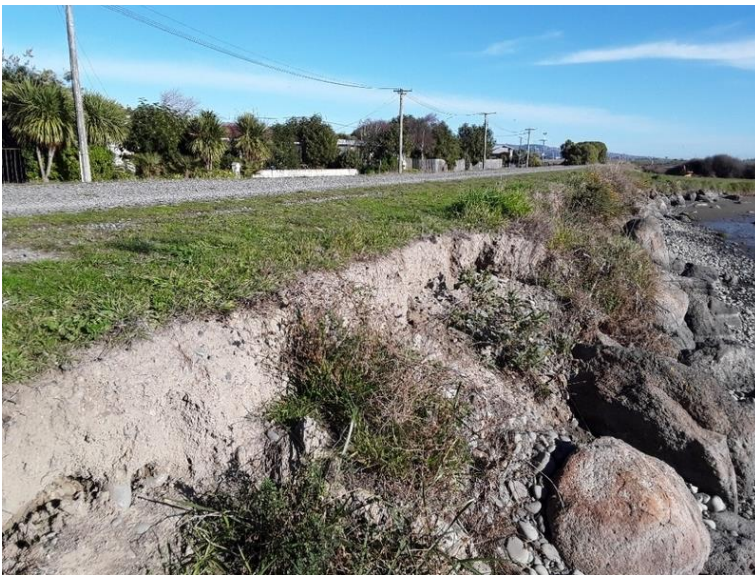
As shown in Table 6, only 2% of the total shoreline of Area 1 had a structure condition grading of 'D' (severe damage affecting 20-50% of structure), being a 38 m length of stopbank along Kibblewhite St (SB4-E) suffering significant erosion on its front face, with large boulders having been sporadically placed to try to halt the erosion (**Figure 8**). It is notable that this section of stopbank is an area where extensive salt marsh is absent from the estuary edge, and is exposed to the longest wind fetch within Area 1, therefore, this is exposed to greater energy at the shore. The only other Kibblewhite St section exposed to the longest fetch without the presence of salt marsh along the estuary edge are sections SB4-A & SB4-B, where the front face of the bank is protected by rock revetment preventing any scour of the front face. Further consideration of the relationship between the structure (and shoreline) condition and the presence of salt marsh could be examined in Stage 2 of the project.

Figure 8: SB4-E Structure condition 'D' where front edge of the structure has shown significant erosion.

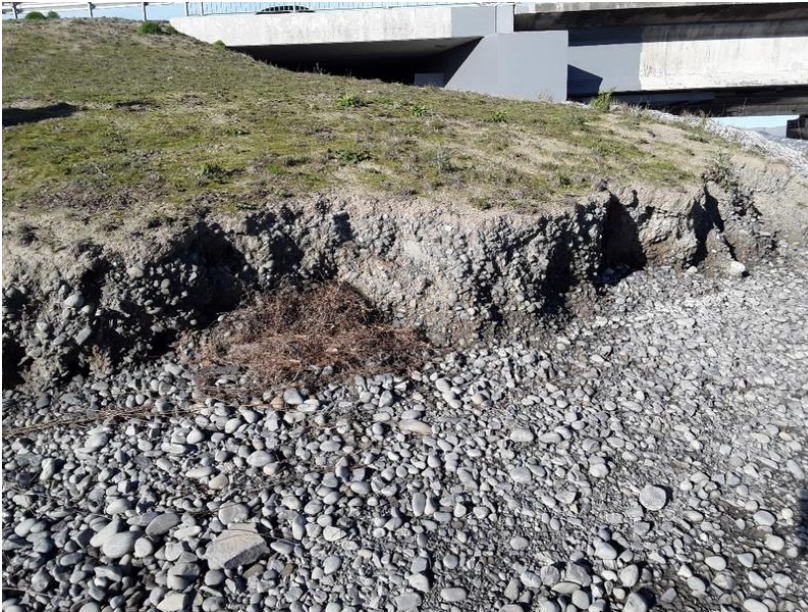
The only section of land erosion in Area 1 was recorded at the grass bank on the north side of Bridge St (NS17-A), where 10 m of erosion scarp up to 0.6m in height, as shown in **Figure 9**.

Figure 9: NS17-A Land condition 'E' – 0.6m erosion scarp on grass embankment north side of Bridge St.

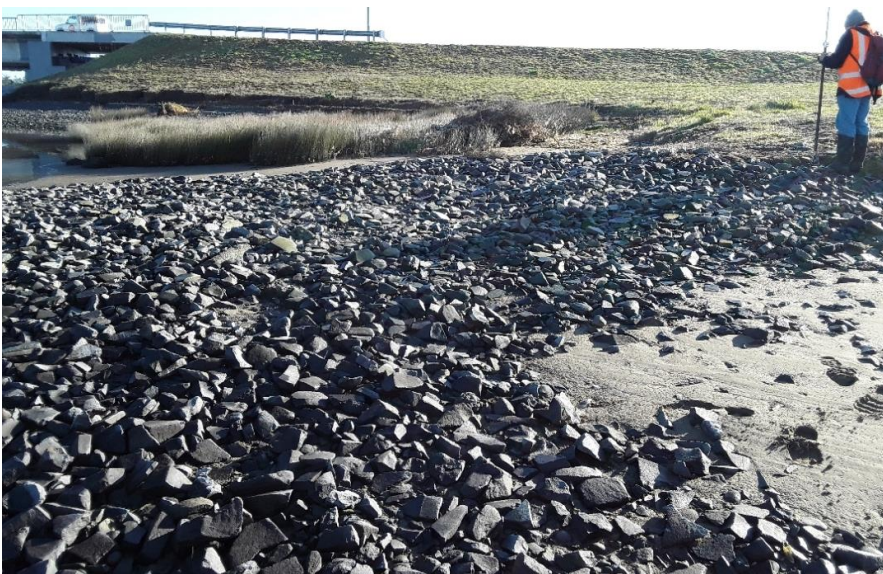
Structure IS47 is a small (3 m shoreline length) informal rock revetment consisting of small angular rocks (**Figure 12**), which are not naturally occurring in estuarine environments, hence the definition as a structure. The age of this revetment is uncertain but is thought to be a similar age as the adjacent 2014 bridge repairs. It is located in a small area where salt marsh is absent from the estuary edge, but it is unknown whether the rock has been placed in-situ or has relocated to this position from placement as part of the bridge protection works. The revetment is has been graded condition 'B' due only to the minimal degree of maintenance required due to its low-lying nature.

Figure 12: Informal rock revetment (IS47-A) south of South Bridge Street

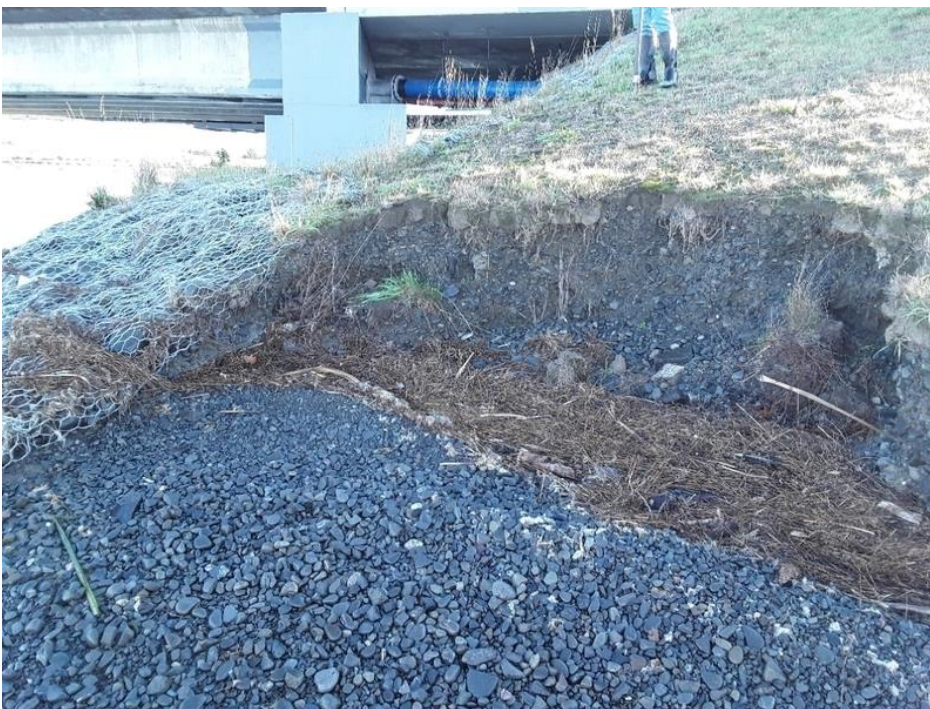
Figure 13: NS16-A Land condition 'E' – 0.6m erosion scarp on grass embankment south side of Bridge St.

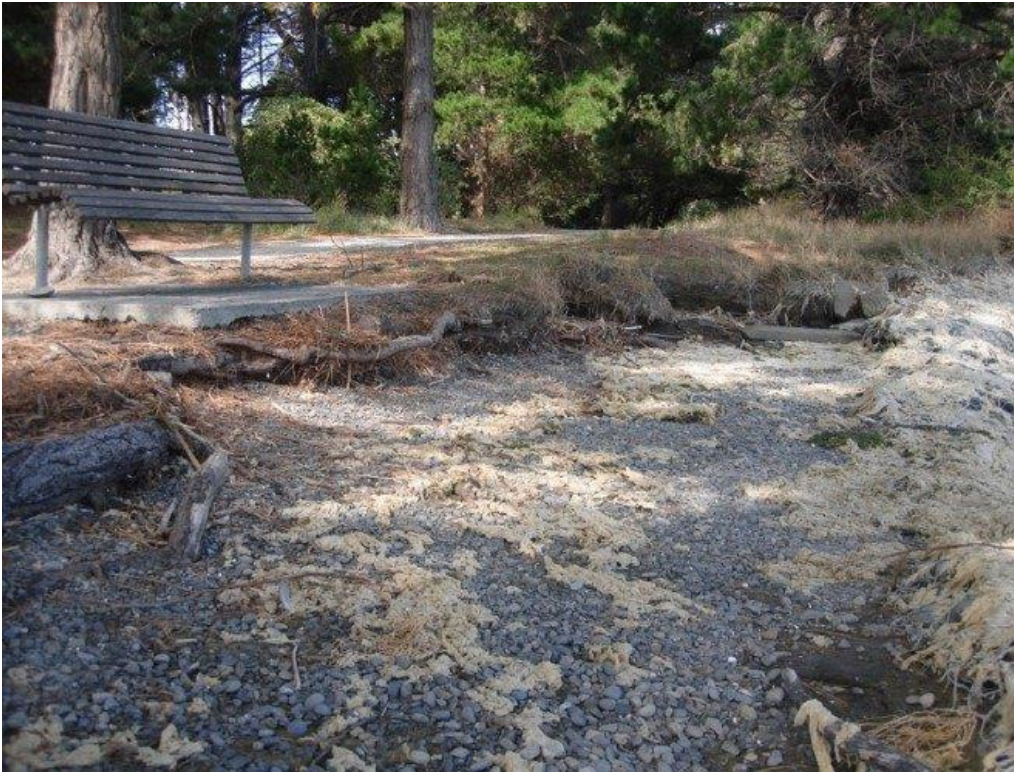
Figure 15: 2008 erosion behind reno mattress in South New Brighton Park (Image Supplied by K Hansen)

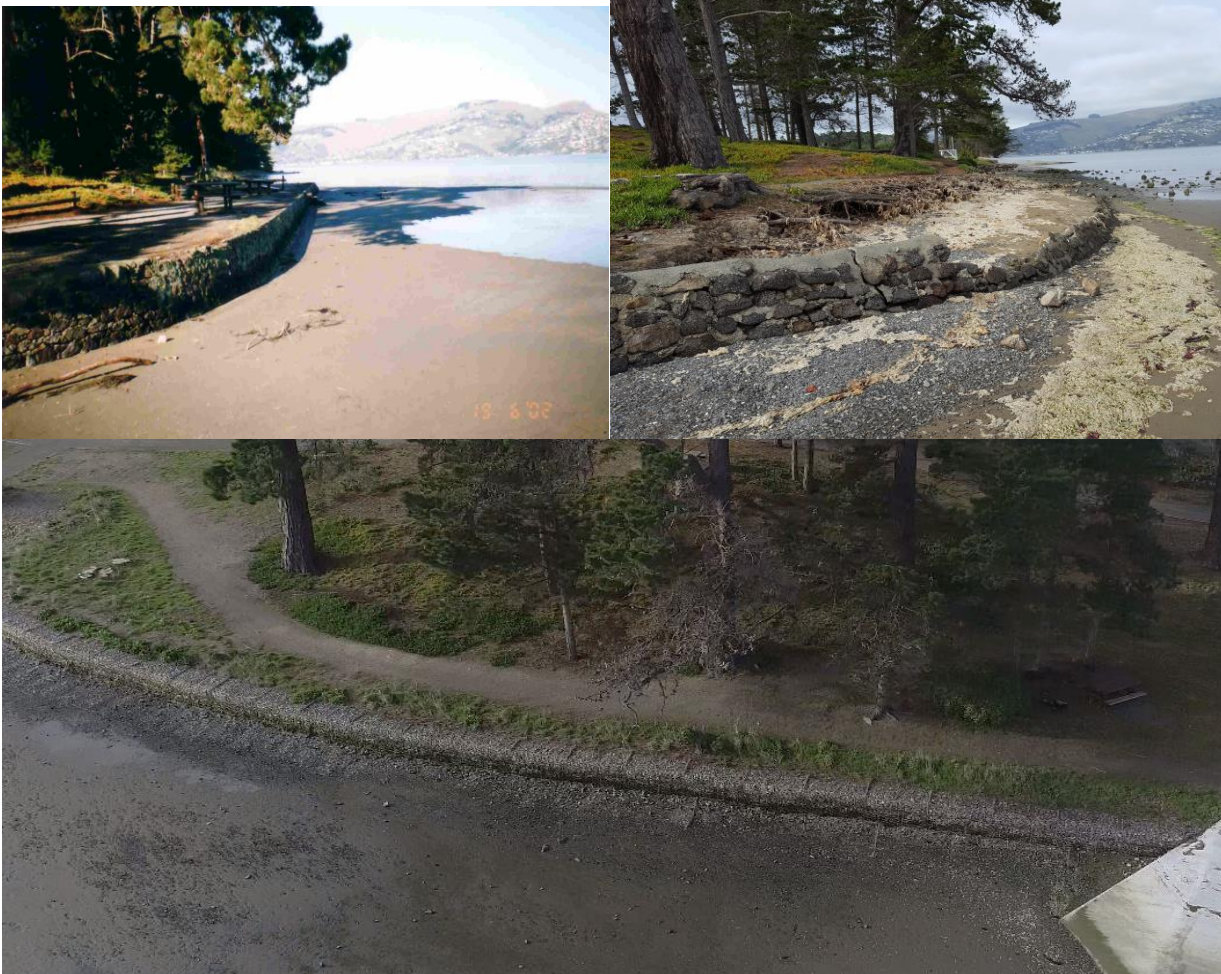
Figure 16: a) Masonry wall south of jetty in South New Brighton Park in excellent condition in 2002 (ECan 2002); b) wall failed and erosion behind in 2017 (Jacobs Image); c) replacement gabion wall (GB3-A & GBRM3-A) in June 2019 (ECan drone image)

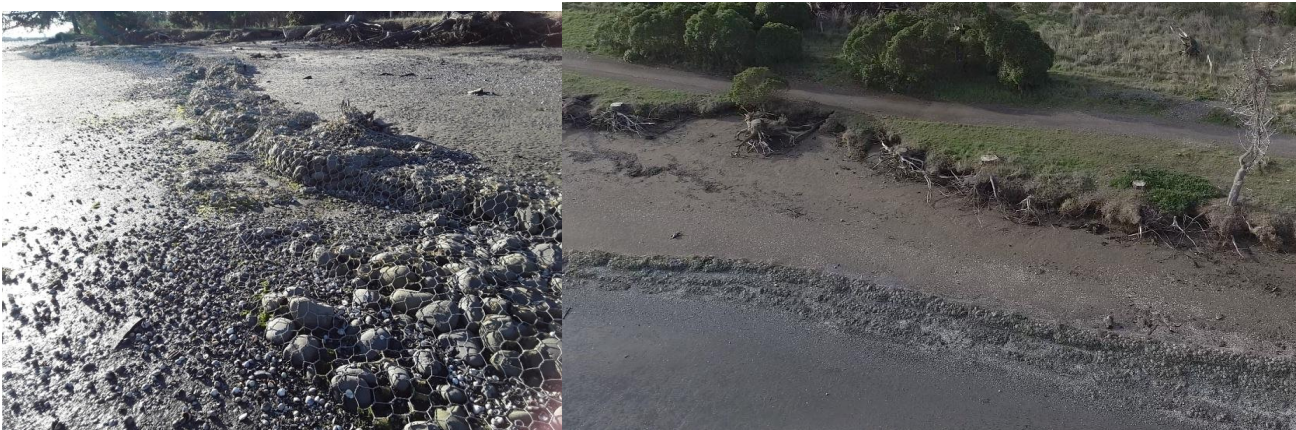
Figure 18: a) Condition 'E' reno mattress in Area 3 (RM2-I) (Jacobs, 2019 image); b) Land Condition behind the structure also graded 'E' due to significant erosion (ECan drone image, 2019).

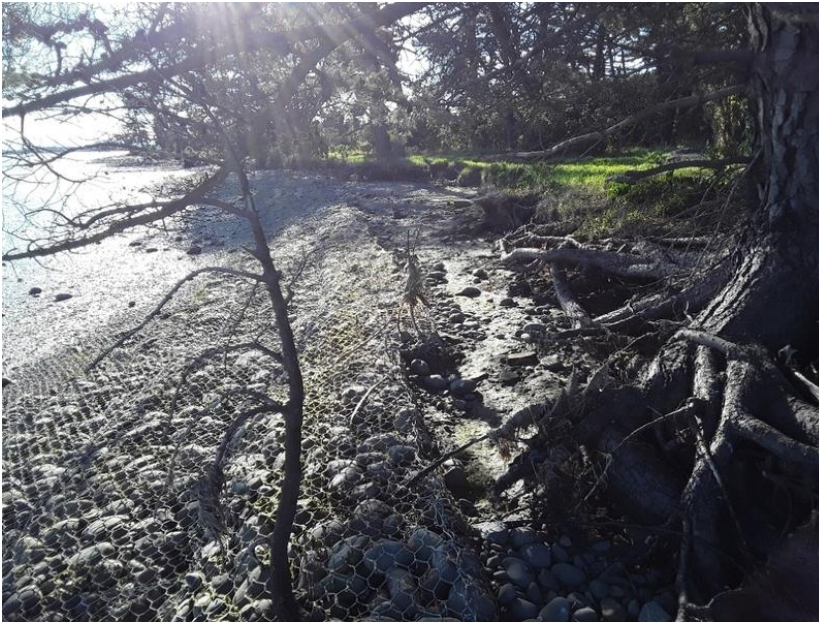
Figure 19: RM2-G Example of Condition 'C' reno mattress with a Condition 'E' coastline (Jacobs, 2019).

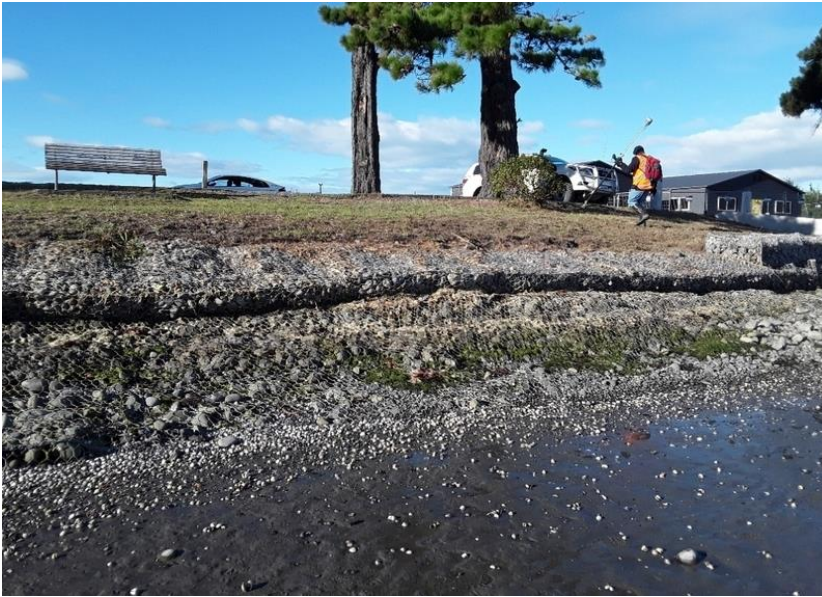
However, in all locations across this area there is a higher bank, shown as the 2019 'high ground' elevation on the mapping, above the structures, which increases the protection against inundation in extreme water levels. This 2019 'high ground' has elevations above the current (2018) 100 year-return period flood level (11.14m) except around the jetty, which have elevations around the current (2018) 50-year return period flood level (11.06m). As shown in **Figure 20**, the 'high ground' above RM5 increases the minimum protection against inundation to around 11.2m.

Figure 20: RM5-A upper layer of reno mattress added in 2017 to 10.8m elevation, with high ground up to 11.2m behind structure (Jacobs, 2019).

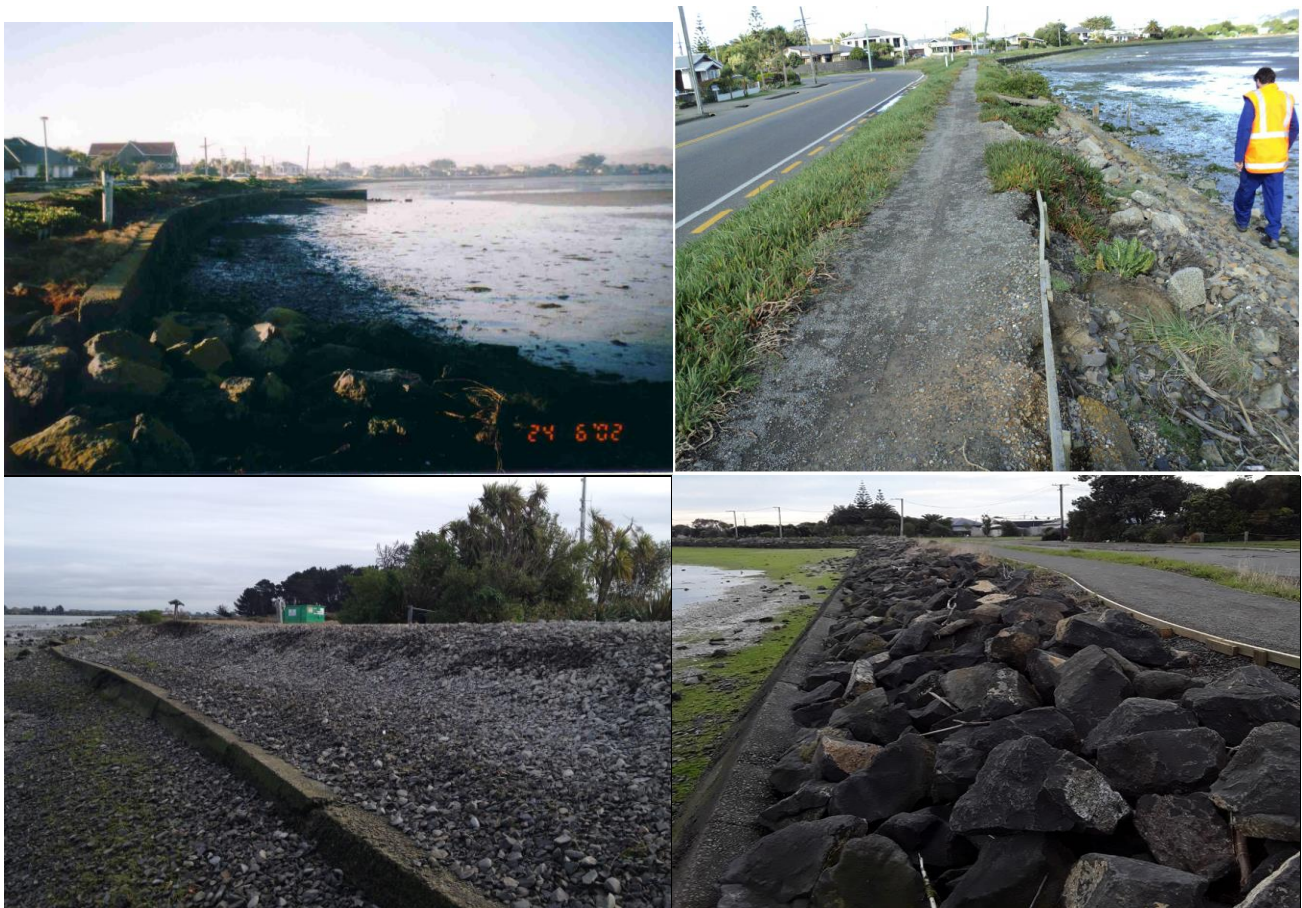
Following the CES, Citycare drafted plans for rock revetment to be put on the estuary edge of the Ebbtide Street stopbank. The original design changed due to damage in king tide experienced in the weeks before installing the revetment (assumed to be high estuary levels in March 2014), with the of the wall following this event being shown in **Figure 22c**. By the end of July 2014 the installation of the revetment on the stopbank had been completed, with the stopbank being in a similar condition as in the 2019 survey (**Figure 22d**).

Figure 22: Ebbtide Street stopbank (SBW1-B): a) 2002 low concrete wall only (Ecan, 2002); b) Following the 4th September 2010 earthquake (CCC, 2010); c) Prior to placement of revetment July 2014 (CCRU image) d) Current stopbank and revetment above original concrete wall (Jacobs, 2019)

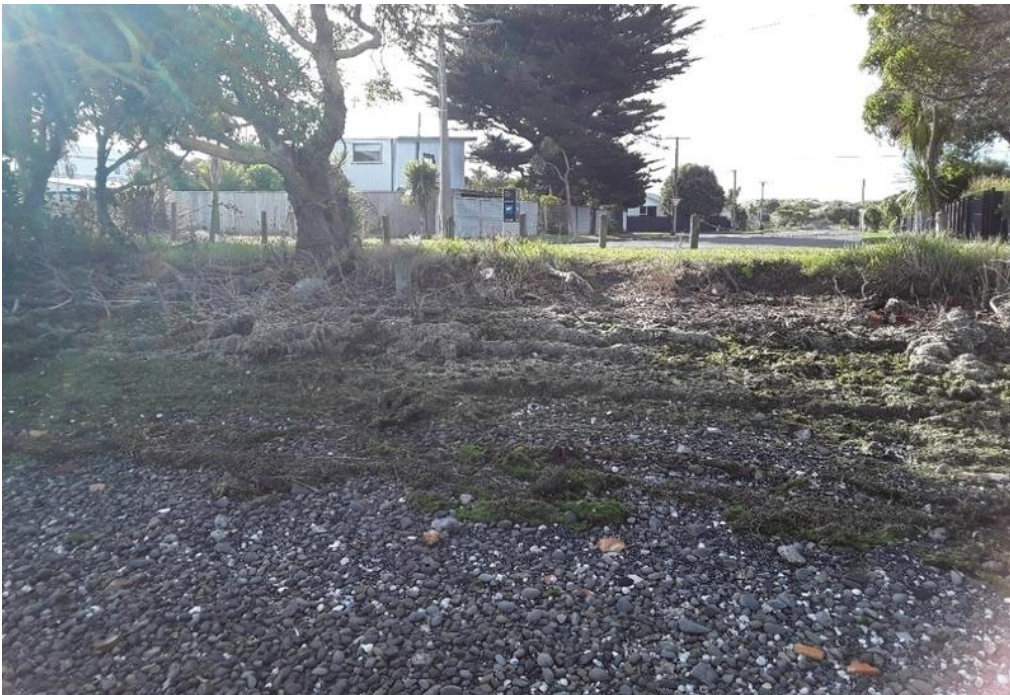
At Godwit Street (NS11) the remnants of a former pebble beach renourishment are evident (**Figure 24**). The concept of renourishment at this location was proposed in Walter (1995), with consent granted in 2000 for the placement of 1,700 m³ of sand and gravel. It is uncertain the actual volumes and locations of the placements. The consent expired in 2005.

Figure 24: Remnants of former pebble beach renourishment at Godwit Street (NS11-A) (Jacobs, 2019).

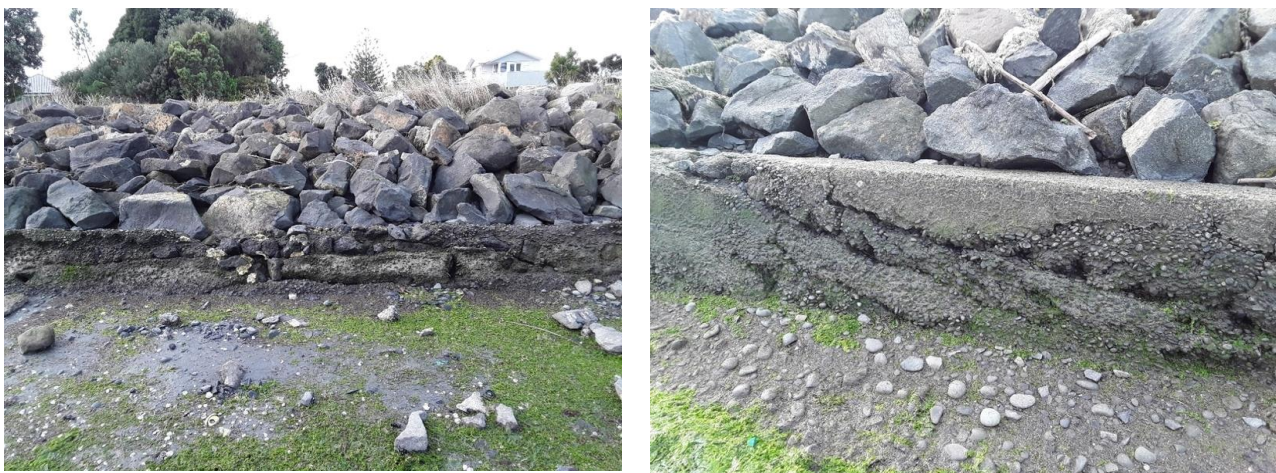
Due to the presence of Ebbitide Street behind the majority of the stopbank length, only the southern 23 m of the bank (SBW1-A) has a land condition grading, along with the 38m further south at Godwit Street (IS40-A and NS11-A). For the small southern stopbank section, the condition is 'A' – no evidence of erosion of vegetation die back, and condition 'C' at Godwit Street due to the presence of a small (< 0.2m) erosion scarp.

Figure 25: Ebbitide Street stopbank (SBW1, SB1, SBW2) recorded damage in 2019 survey (Jacobs, 2019)

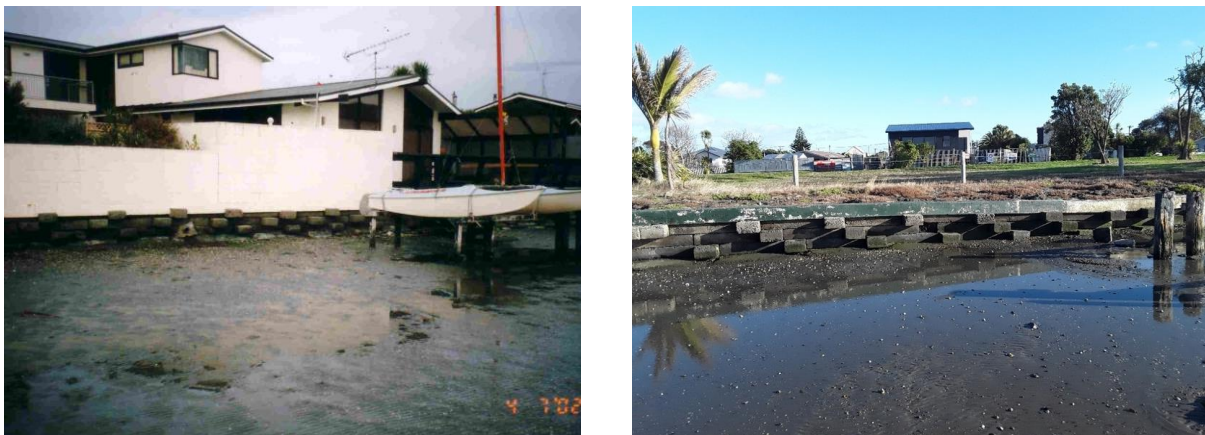
Figure 27: Structure IS7 -156B Rockinghorse Rd (Area 5e) a) in 2002 showing a seawall with 'Satisfactory' and b) in 2019 with structure condition grading 'E' (Jacobs, 2019 image).

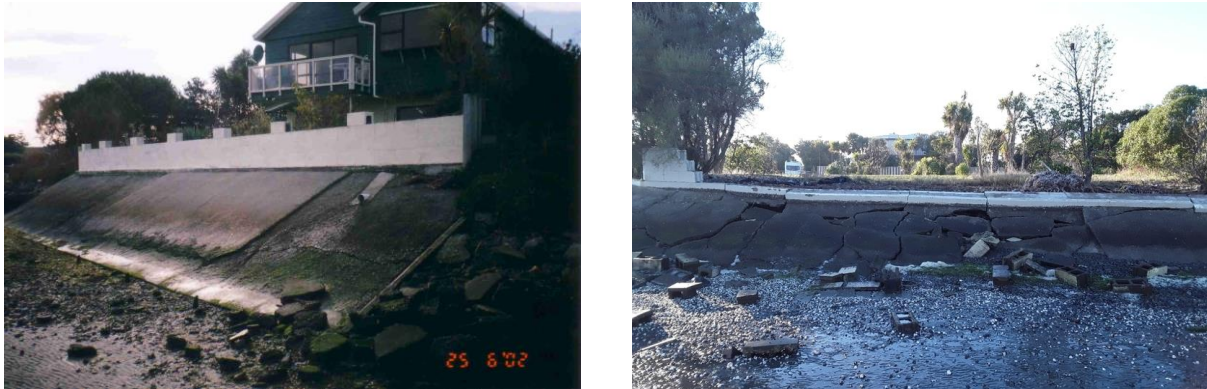
Figure 28: Structure IS32 – 9 Kingfisher Lane (Area 5b) a) in 2002 showing a “satisfactory” seawall (ECan, 2002), and b) in 2019 with structure condition grading ‘D’ (Jacobs, 2019 image).

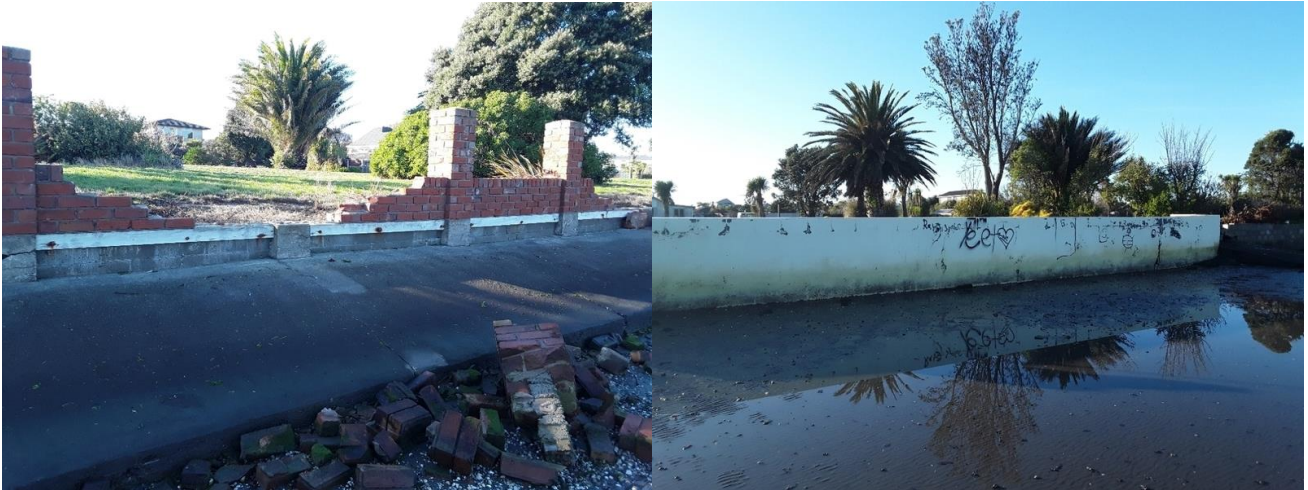
Figure 30: Examples of structure condition grading 'D': a) Structure ISIS1 – 126A Rockinghorse Rd (Area 5c); b) Structure IS14 -136B Rockinghorse Rd (Area 5d). (Jacobs 2019 images)

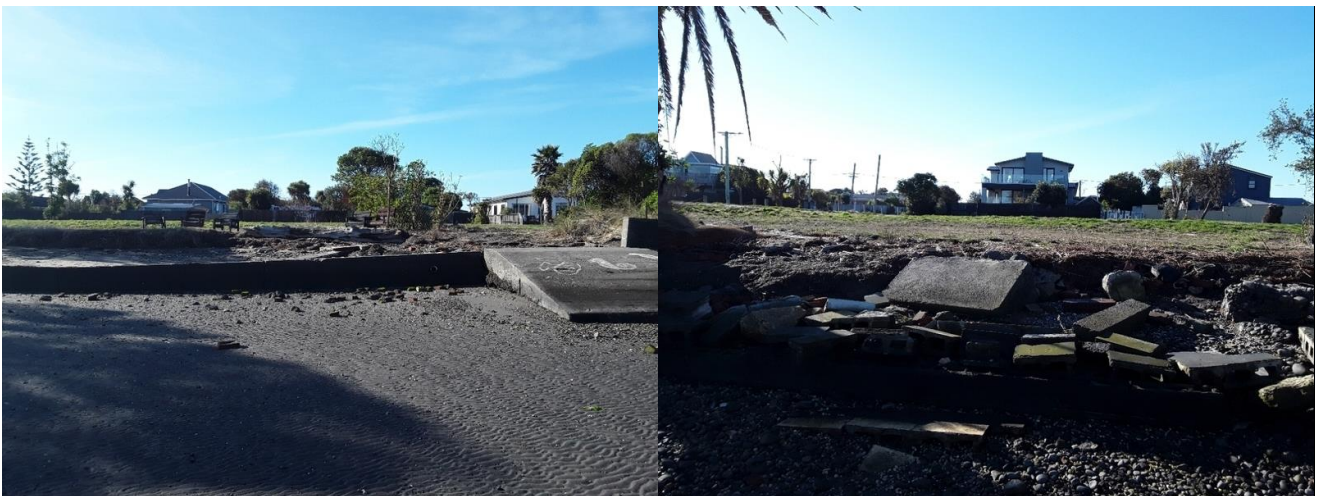
Figure 31: Examples of structure condition grading 'E': a) Structure IS23 – 104A Rockinghorse Rd (Area 5d); b) Structure IS20 - 4 Plover Street (Area 5d). (Jacobs 2019 images)

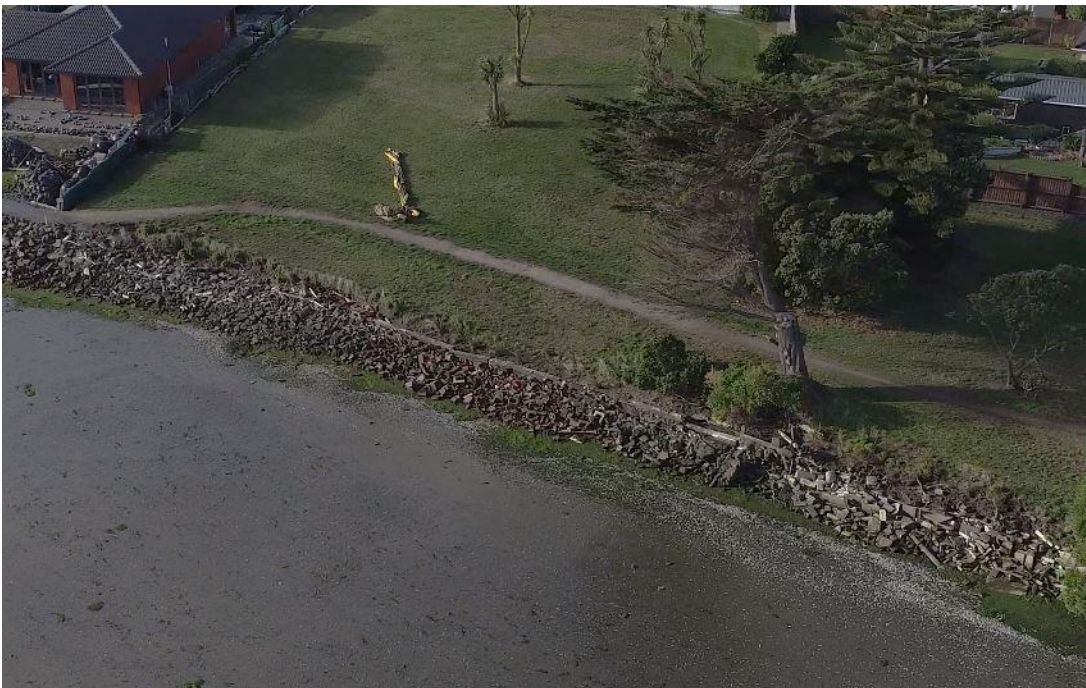
Figure 33: Structure IS34-A north of Heron Street, lowest structure elevation of 10.46m and average of 10.82m. Structure condition grading 'C' and land condition grading of 'D'

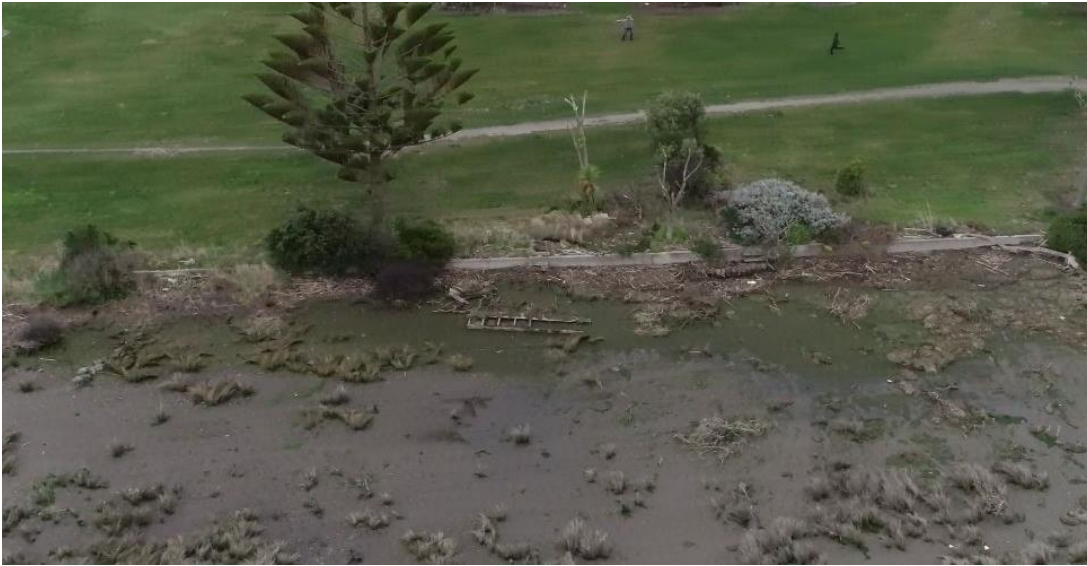
Figure 34: Structure IS30-A, Low concrete wall the same as present in 1995 and 2002. Structure elevation 10.9m with land condition 'B'.

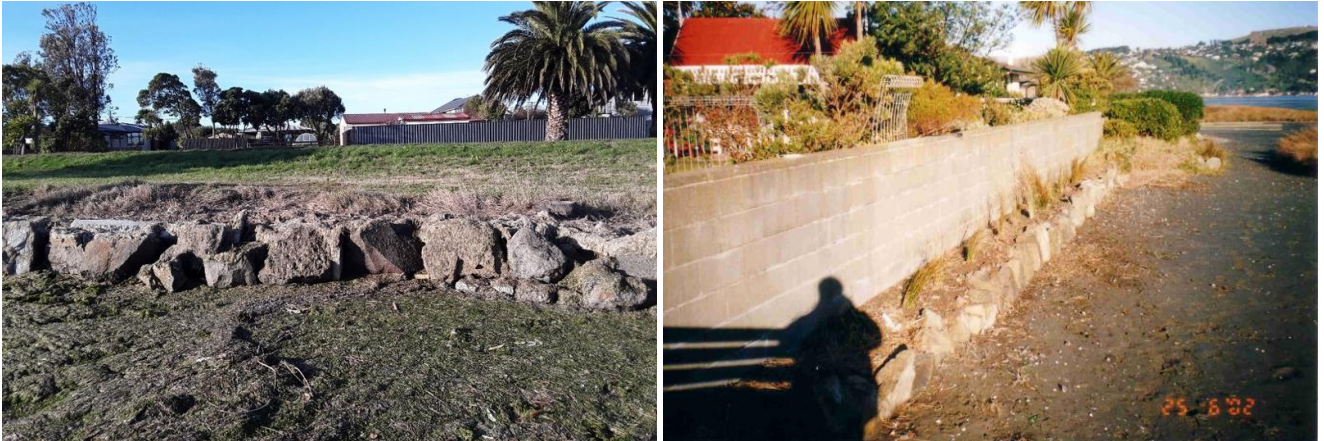
Figure 35: Structure IS26. Minimum 2019 structure elevation in Area 5b. a) 2019 condition -single line rock revetment; b) 2002 concrete block wall above rock revetment. Current land condition 'D'.

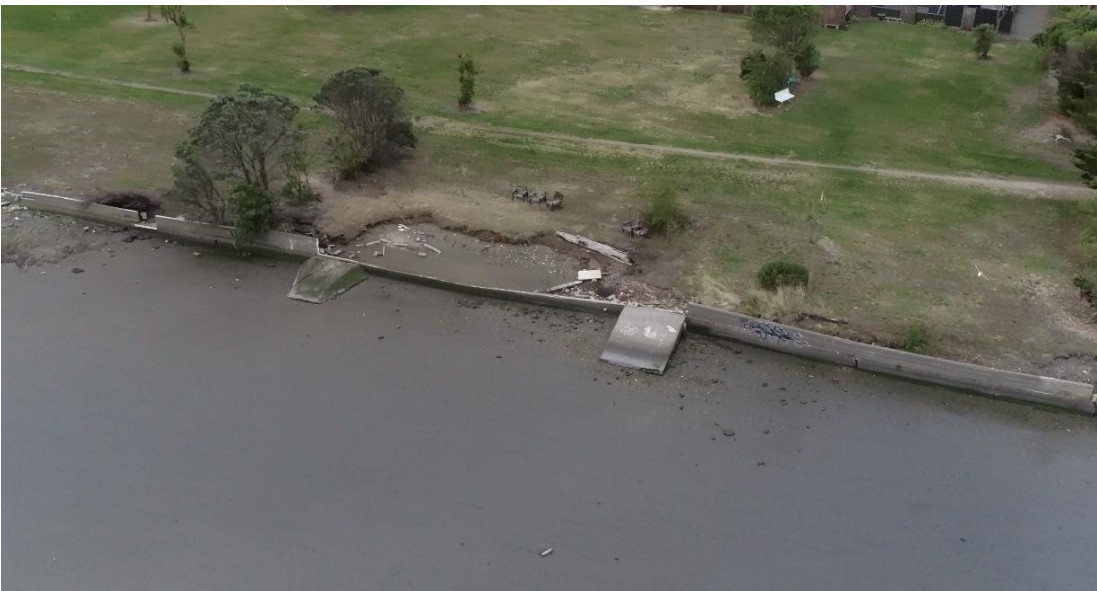
Figure 37: Structure IS23-A, Variable remnant structure elevations- Wall sections above 11.2m, and low foundation sections 10.25m with 3.5m of erosion behind.

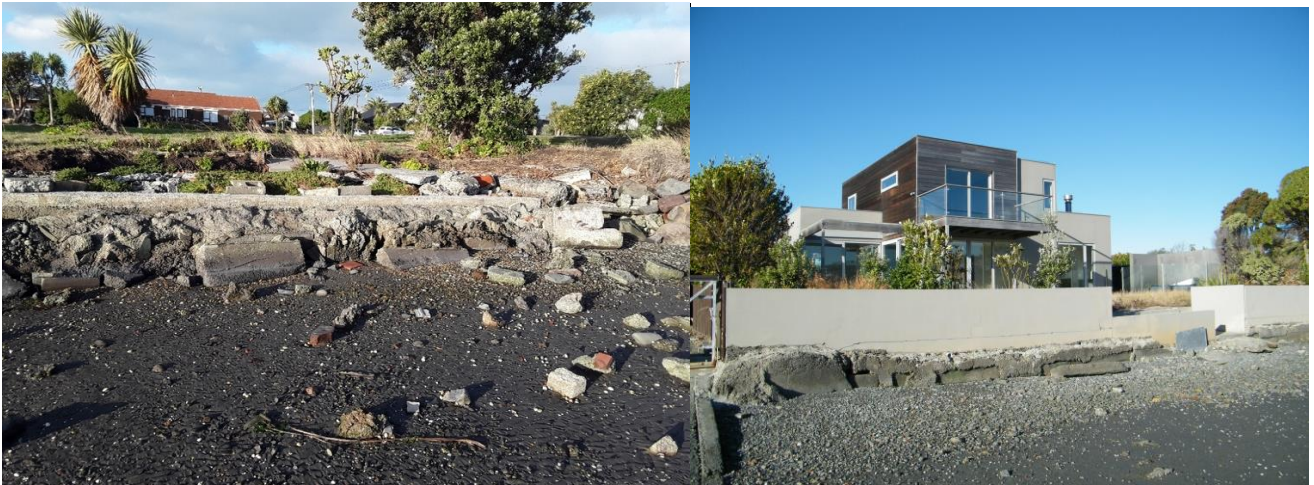
Figure 38: Structure IS10-A: a) 2019 low elevation foundation remains of former concrete wall (Jacobs 2019); b) Current structure elevation 10.6m, structure condition 'D', land condition 'D' (A. Crossland 2014).

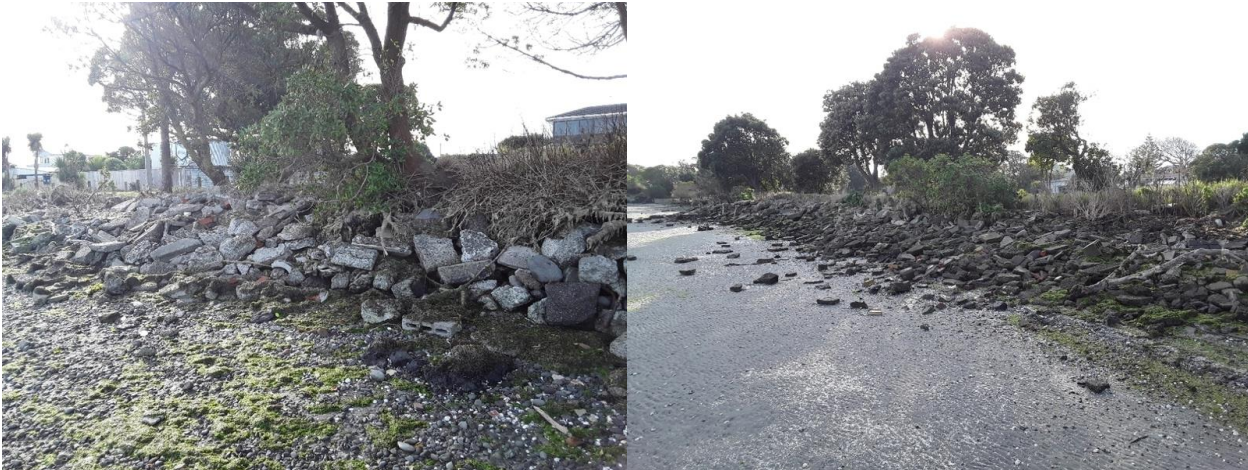
Figure 41: Locations of informal fill between Godwit and Heron streets (Area 5a) with 2011-2019 erosion >4m a) Structure IS39-A, immediately south of Godwit St, and b) Structure IS23-A approximately 90m south of Godwit St. (images Jacobs, 2019).

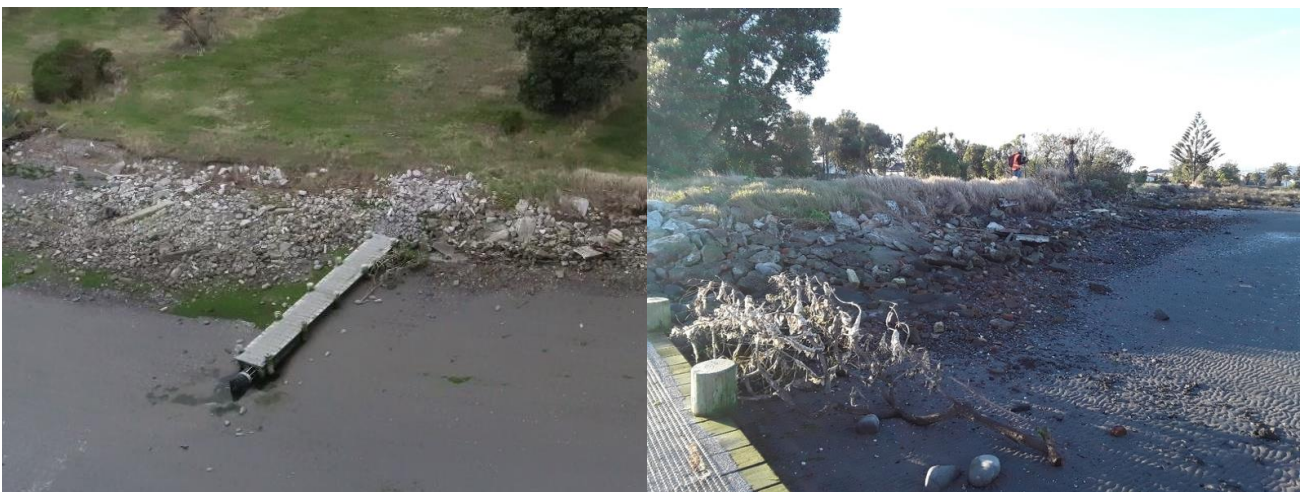
Figure 42: Location of informal fill between Heron and Penguin Streets (Area 5b) with 2011-2019 erosion >4m. (image a) from ECan Drone, 2019; image b) Jacobs, 2019).

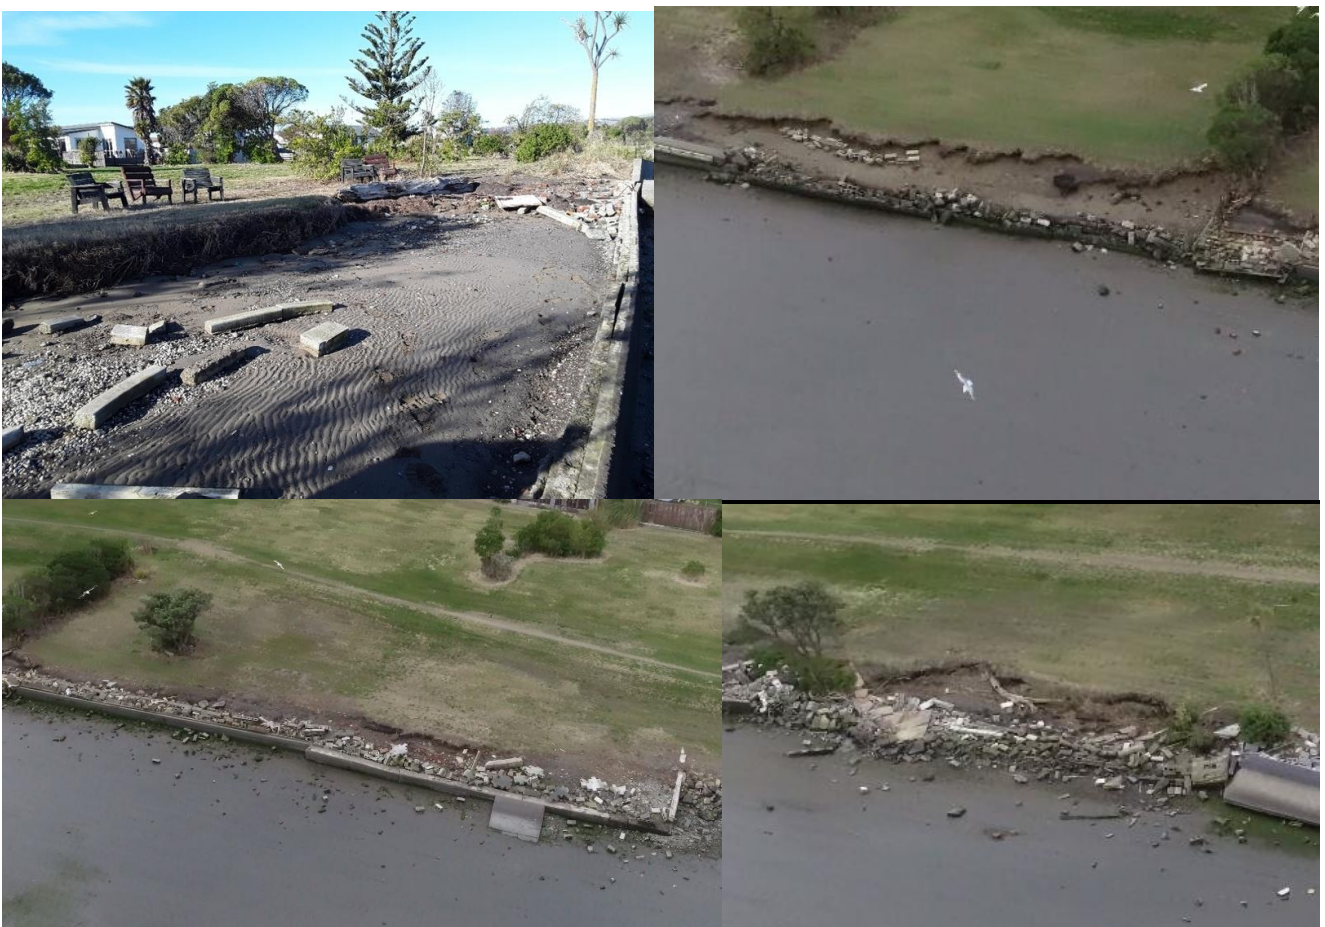
Figure 43: Location of significant erosion scarps behind remnant wall structures between Penguin and Plover Streets (Area 5c) a) IS23-A, erosion 3.5m; b) IS22-F, erosion 2.3m; c) IS22-E, erosion 2.7m; d) IS22-A, erosion 2.8m.
