Avon-Heathcote Ihutai Estuary Edge Condition Inventory

Christchurch City Council

IZ128500-A.CS.EV.1-NM-RPT-0001 IZ128500-NM-RPT-0001| B

12 August 2019

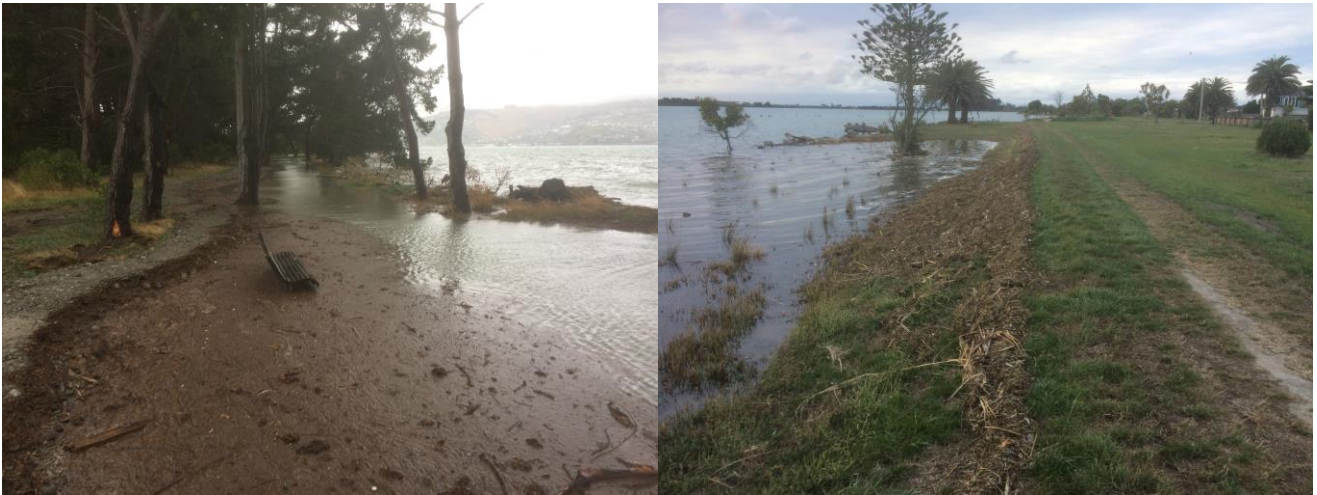
Figure 3: Inundation of estuary edge in highest recorded water levels on 2nd February 2018. a) South New Brighton Park, b) Southshore south of Penguin Street. (Images supplied by CCRU).

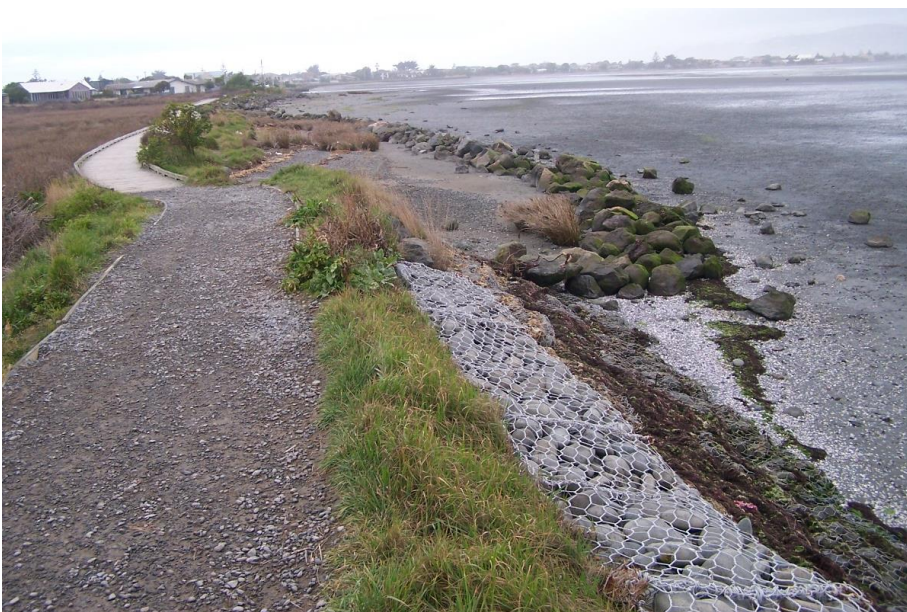
At the southern end of Area 3, the boardwalk across Jellicoe Marsh is thought to have been constructed around 1995. It is reasonable to assume that the raised bank and track at the northern end of the Marsh and reno (RM1) was constructed at the same time. As shown in **Figure 16**, repairs to this reno appear to have been carried out circa 2009. There is reference to a small bund being placed on the western side of the boardwalk to protect it and the salt marsh, with a continuous low rock wall revetment or breakwater also being described in 2002 as being in front of this bund (see **Figure 17**). There were concerns about erosion of the bund prior to the CES as noted in the South New Brighton Reserves Management Plan 2010, and council records post the CES report that the bund had eroded away. The boardwalk and detached rock breakwaters (IS46 to IS42) that act as a wave trip and incorporating gaps for water passage into the salt marsh, were rebuilt in 2017.

Figure 17: Reno mattress (RMRV1, RM1-A) in good condition at north end of Jellicoe Marsh Boardwalk in 2009 prior to the CES (Image Supplied by A Crosslands, 2009)

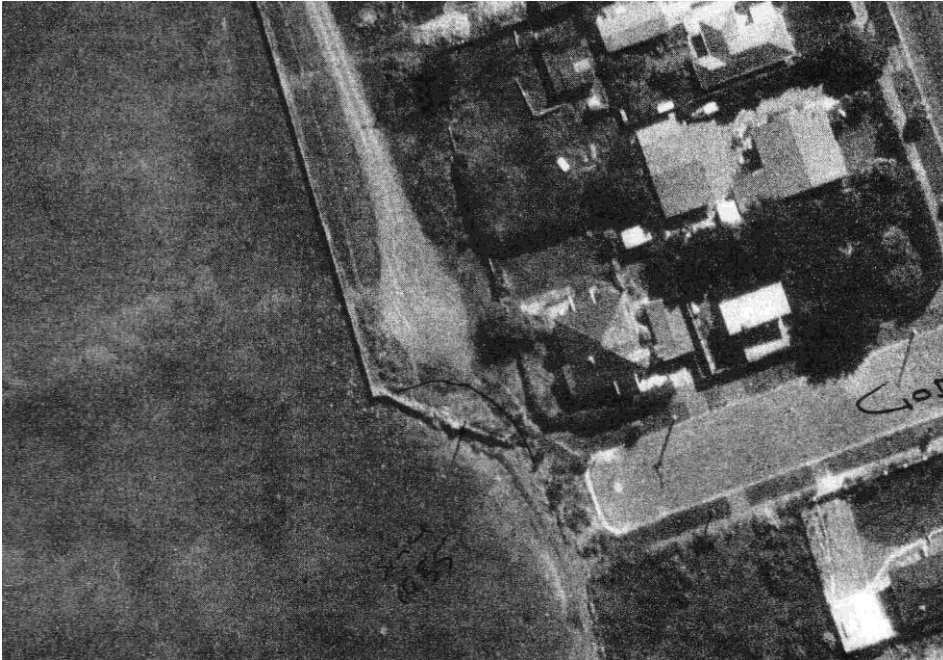
The informal rock revetment, IS40-A, at the southern end of the stopbank is recorded in the ECan 2002 inventory as being present since 1967 and as closing -off the reclamation behind the concrete wall to the north. (**Figure 23**).

Figure 23: Stopbank (SBW1-A) and informal revetment (IS40-A) forming reclamation at the north side of Godwit Street 2002 (ECan 2002)

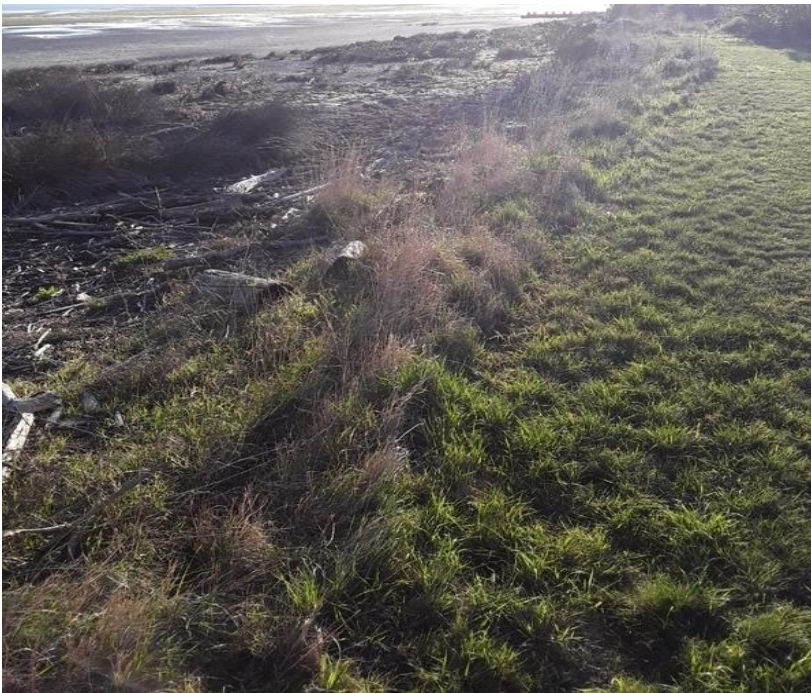
As also shown in Table 19, there is only 140m of Area 5 north of Tern street without structures or the remnants of structures along the estuary edge. However, it is noted that around 72m of this length there were former structures that have been totally removed (Area 5c, sections NS6 & NS5), with the land condition now being graded as condition 'D'. Of the remaining length of coast without structures, 34m (Area 5b, sections NS9 & NS10 - **Figure 32**) was graded as land condition 'A' (no evidence of recession or scarping). It is notable that in both of these areas salt marsh was present on the upper estuary bed, providing a buffer to wave energy arriving at the shoreline. Further investigation into the relationship of salt marsh to erosion distances and land condition could be included in stage 2.

Figure 32: Section of no structures (NS10, Area 5b) with land condition grading 'A'.

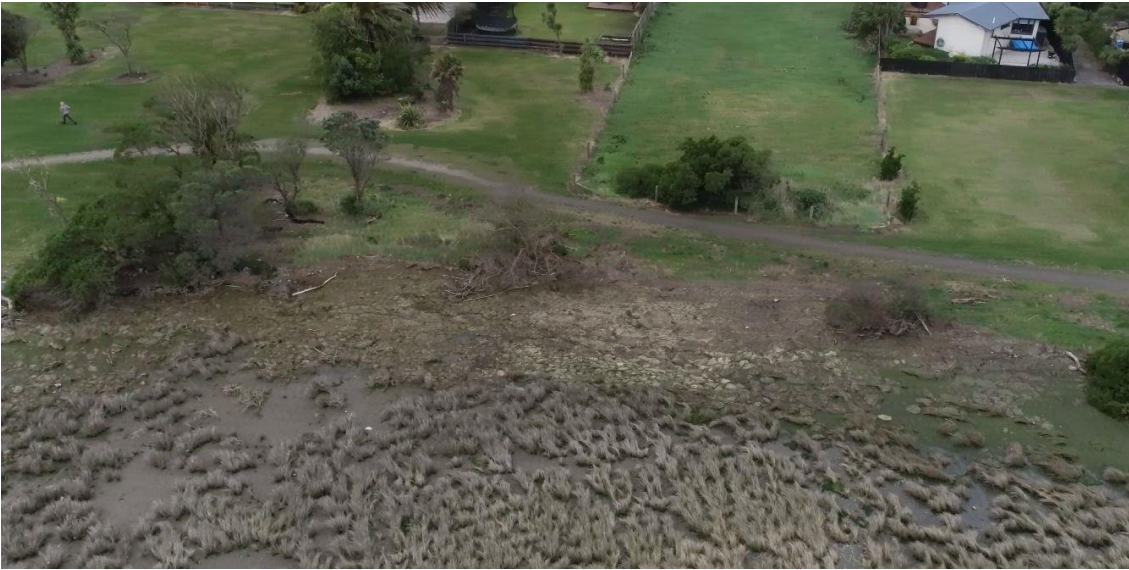
The lowest section of 'high ground' corresponds to a section of no structures (NS9 chainage 5125 to 5190, **Figure 36**), which has general elevations in the order of 10.6 -10.7m. Despite these low elevations, this section of shoreline has the highest land condition of 'A' with no evidence of recession, scarping or vegetation die back. This may be due to the presence of salt Marsh on the upper intertidal bed as shown in Figure 36 reducing wave energy along this section of shoreline. This relationship between estuary edge condition and salt marsh occurrence and abundance could form part of the stage 2 investigations.

Figure 36: Structure NS9-A, No structures. General land elevation at estuary edge of 10.6m. Land condition 'A'.

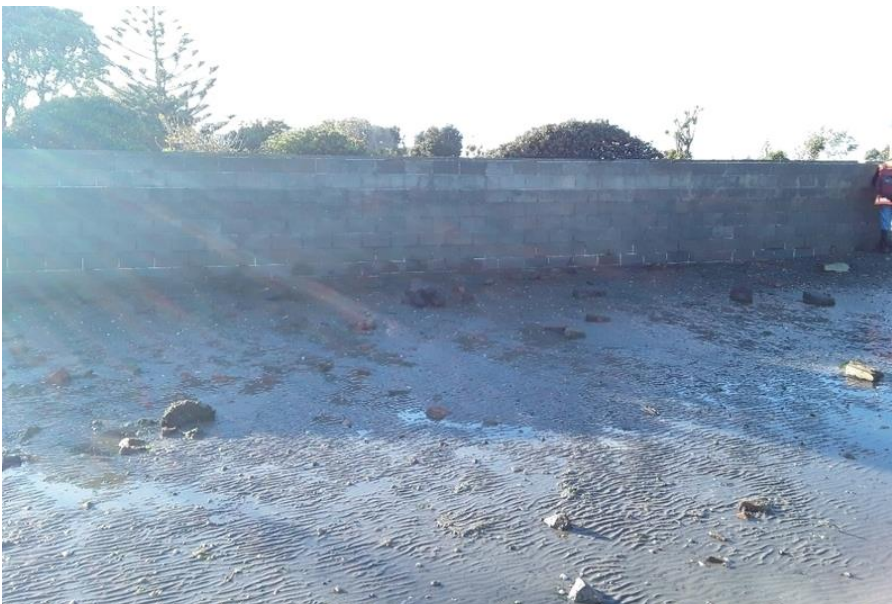
Figure 39: Structure IS16-A, remaining concrete block wall to elevation 11.3-11.9m. (Jacobs 2019)

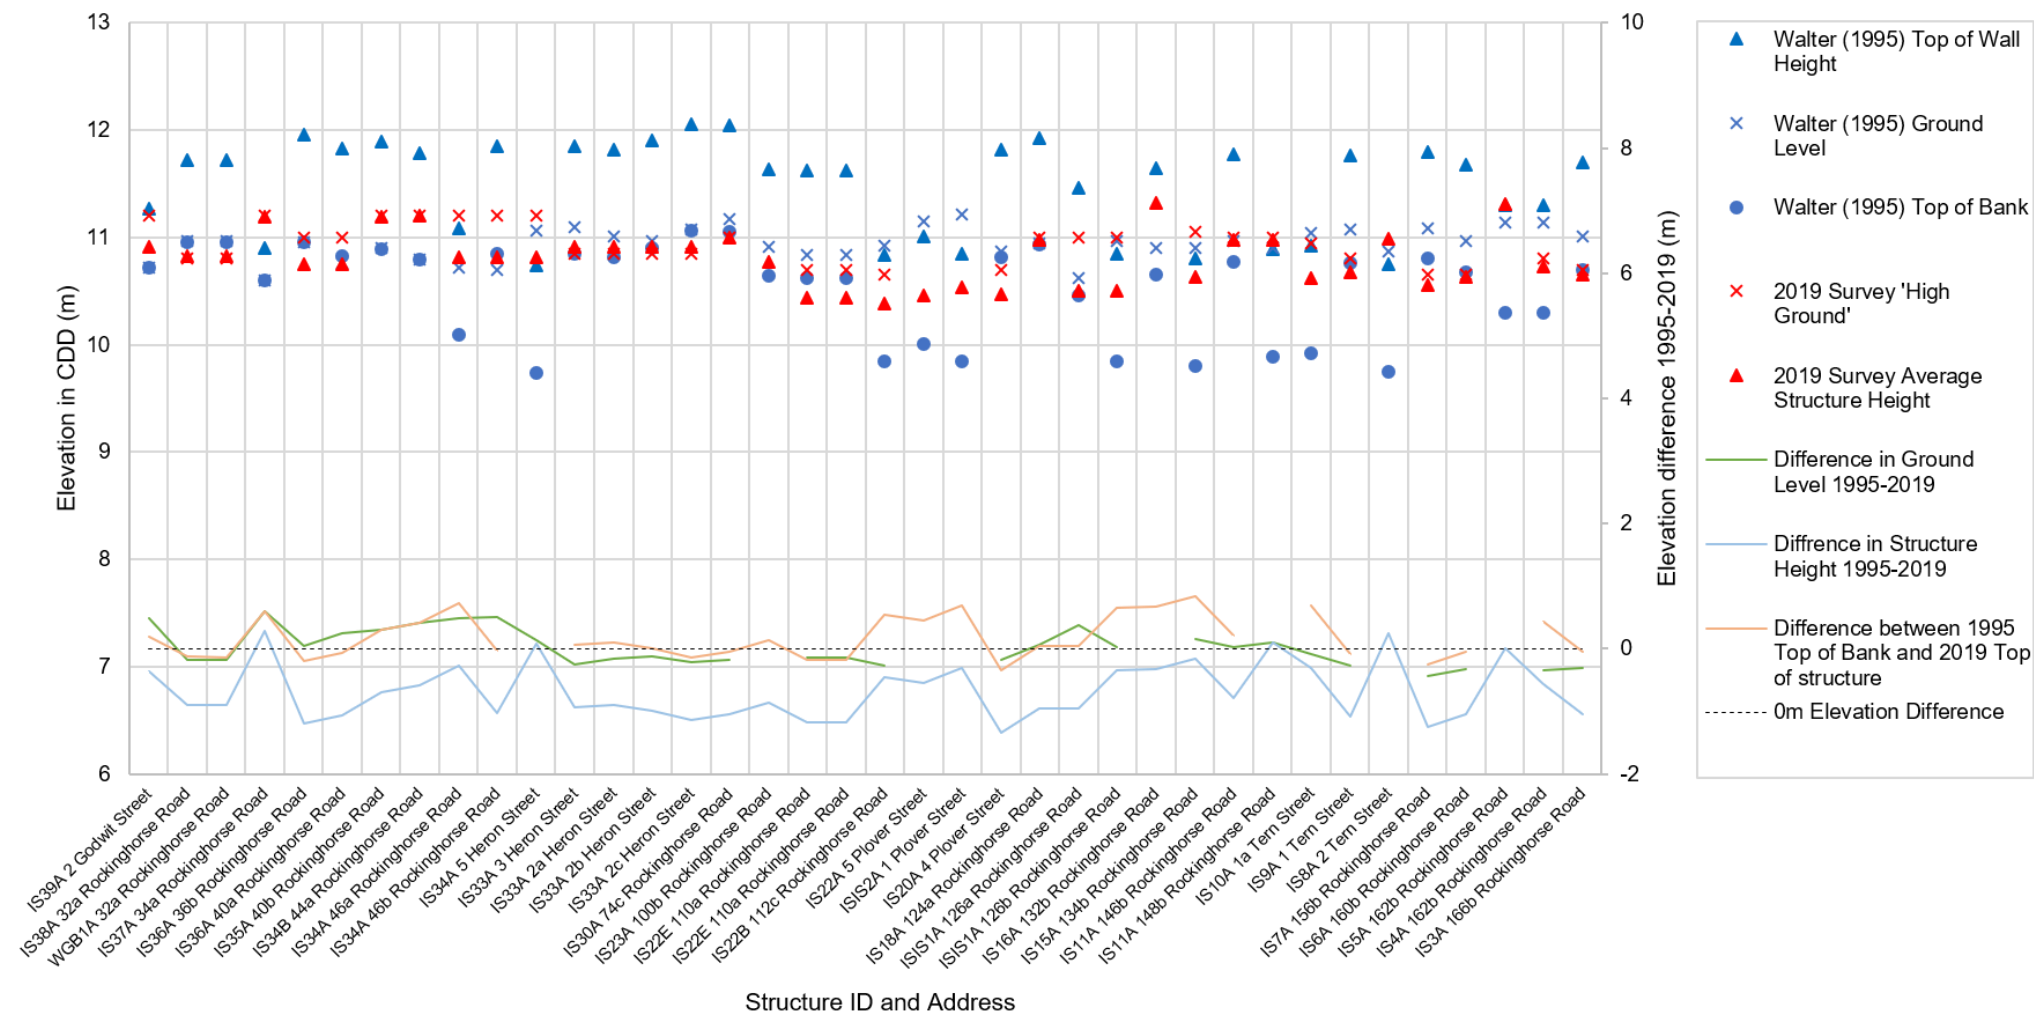
A further comparison was undertaken between the elevation of the 2019 structure (where not a free-standing wall) and the top of bank in 1995 as an indication of the degree to which the existing remnant structures may be providing erosion protection by increasing elevation above the natural edge. The results showed 20 properties had an increase by an average of 0.4m, suggesting a likely erosion benefit of the remnant structures over the natural edge by reducing overtopping frequency and magnitude. However, there were also 14 properties which have had a decrease in elevation by an average of -0.15m, therefore likely that the erosion benefit of the remnant structures would be less.

Figure 40: Comparison of structure and estuary edge elevations between 2019 survey and data from Walter (1995)
